PROBING OF HERMEAN EXOSPHERE BY ULTRAVIOLET SPECTROSCOPY

XUV anomalies

PHEBUS TEAM MEETING - June 13, 2022 – Montigny le Bx

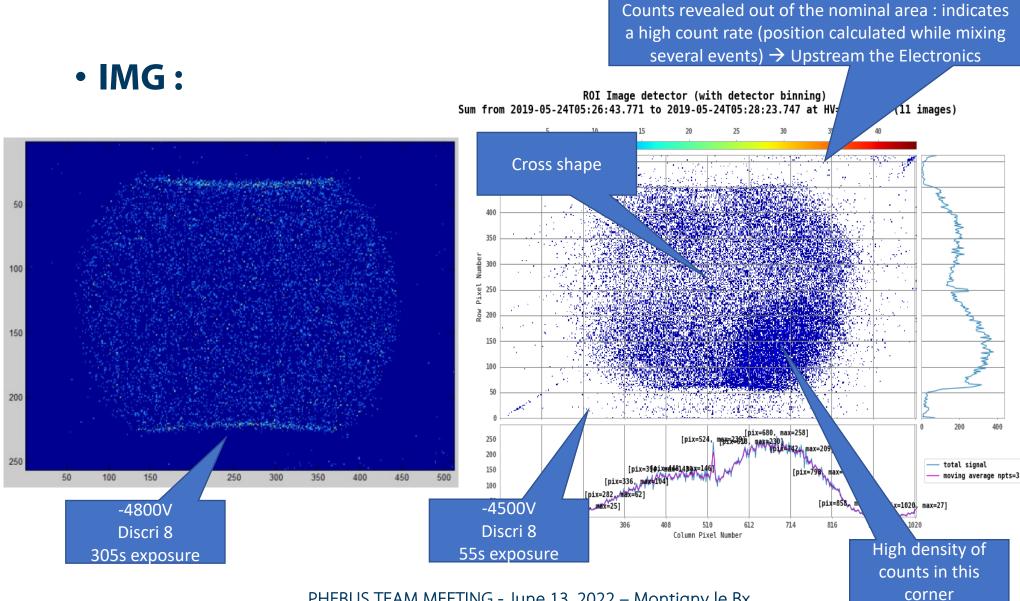
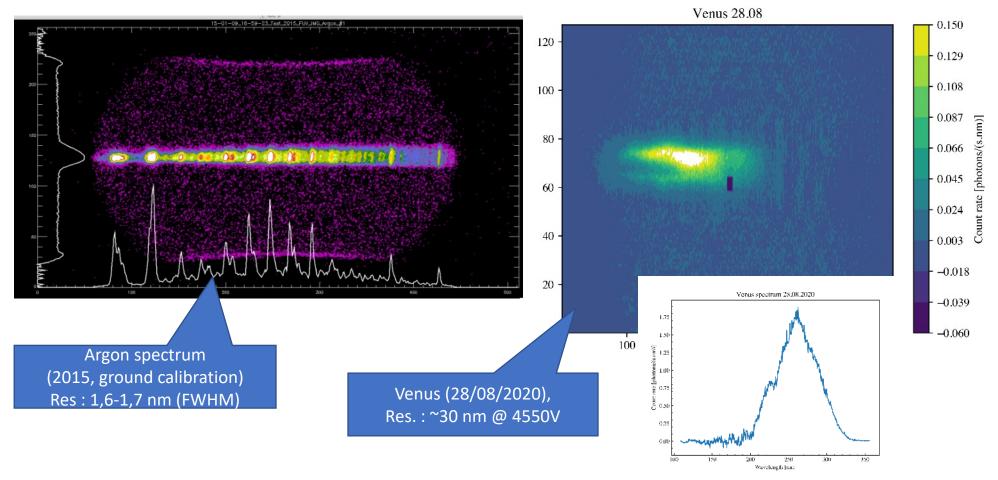
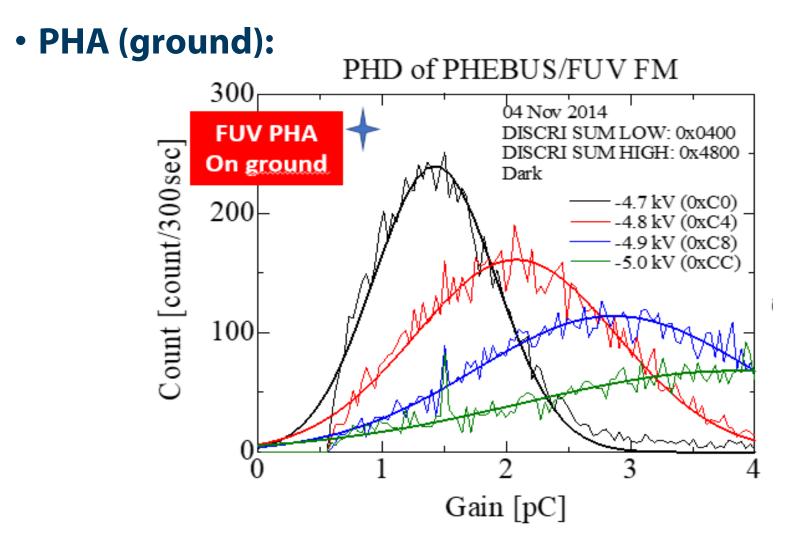
- During the commissioning of the detectors with HV ON (May 2019) the FUV have shown a high level of noise.
 - Dark count : 100 to 1000 times higher than on ground
 - Spatial distribution of the counts is not homogeneous
 - Noise increase \rightarrow resolution degraded (barycentre calculation)
 - High count rate \rightarrow limited lifetime
 - Behaviour of the detector is stable since 2019
 - Something happened between Oct18 and May19
 - Root cause not understood (radiations, electrostatic effect, internal outgassing, ...)

- « Play » with the Discri values
 - The idea : If the noise corresponds to counts having a low charge (which is usually the case), increasing the discriminators thresholds would remove it partially.
 - Increasing the Discri value has a positive effect on the detector's performance, but does not allow recovering the expected performances.
 - « Optimum setpoint » : ~4.8kV/Discri14
- « Play » with the discri mode (« or »/« and »)
 - The idea : The « AND » mode selects only the events that are « seen » by all four channels of the RAE, while the « OR » mode (usually used) selects the events if at least one channel sees it.
 - On the paper, using the « AND » mode can improve the SNR at the center of the detector. But after having tested it, this option is not considered anymore (useful area significantly reduced).

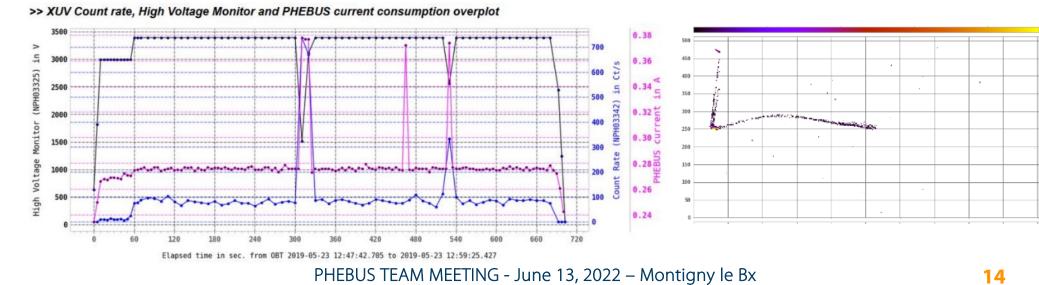
- During the commissioning of the detectors with HV ON (in May 2019) an « event » occured during a HV ramp on the EUV detector, showing simultaneously :
 - Count rate increase
 - PHEBUS primary current increase (monitored by the S/C)
 - HV drop
 - + image acquired showing a specific pattern (« trail »)

Discharge/avalanche ?

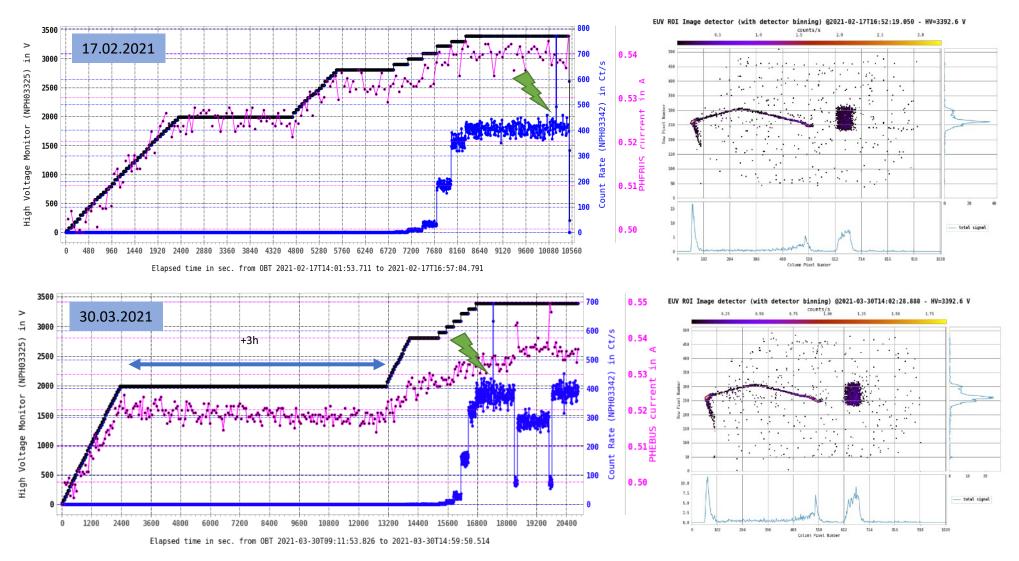
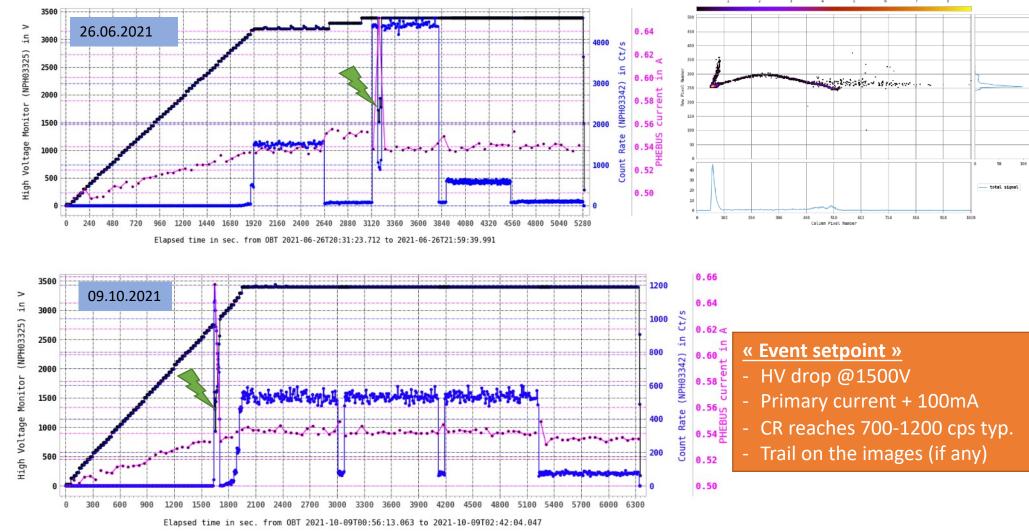
- 11 occurrences since May 2019 (barely 50% of the observations)
- The symptoms are ~stable (CR, primary current, HV monitoring, images)
 - No clue in the others HKs (voltages, temperatures)

- Typical duration of an event : few tenths of seconds (10 70 s)
- The occurrence of the event does not damage the detector (except possible stress)
- After an occurrence, the detector recovers and science continues as if nothing had happened (no idea about a possible repetition rate)

- No degradation seen on the sensitivity of the detector (i.e. no hot spot nor cold spot)

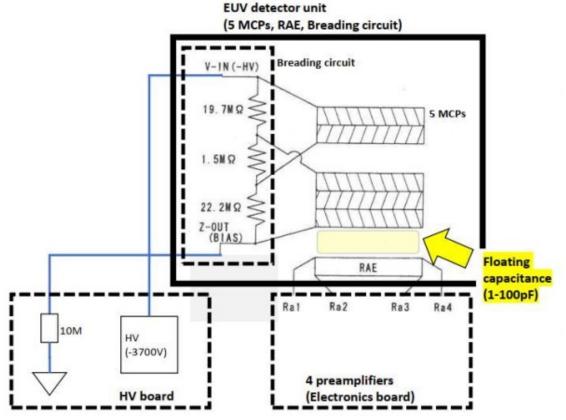
- Parasitic capacitor between the RAE and MCP generates « ghost counts » when the HV fluctuates.
- We know that the HV varies during the event (previous slides)
- Currently investigating whether we can verify this by test with the EUV FS :
 - Test #1 : Direct measurement of the capacitor
 - Test #2 : Pulse injection on « Bias » while operating the detector
